*Vibrations caused by ship traffic on an
ice-covered waterway*

F.D. Haynes and M. Määtänen

April 1981

Prepared for
U.S. ARMY ENGINEER DISTRICT, DETROIT
By
UNITED STATES ARMY CORPS OF ENGINEERS
COLD REGIONS RESEARCH AND ENGINEERING LABORATORY
HANOVER, NEW HAMPSHIRE, U.S.A.

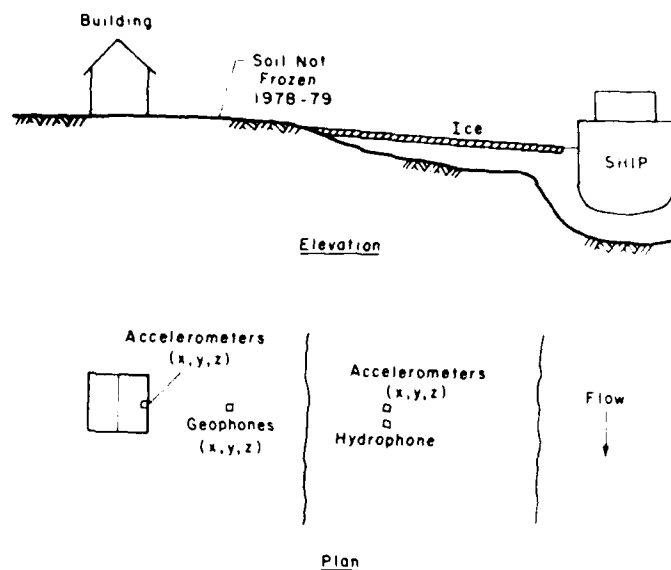
Figure 3 shows the general instrumentation layout. Three accelerometers were mounted on a steel plate that was tack welded to a pipe frozen into the ice sheet. The x and y direction accelerometers were oriented perpendicular to and parallel to the ship channel, respectively, while the z direction accelerometer was vertically oriented. Accelerometers mounted on the ice are shown in Figures 4 and 5. A close-up view of the accelerometer mounting on the ice is shown in Figure 6. A 6.35-mm wire rope is shown attached to the mounting plate. This wire rope was connected to a steel rod driven into the soil on shore. When the ice moved, the tack welds failed, separating the mounting plate from the

Figure 3. Vibration instrumentation layout.

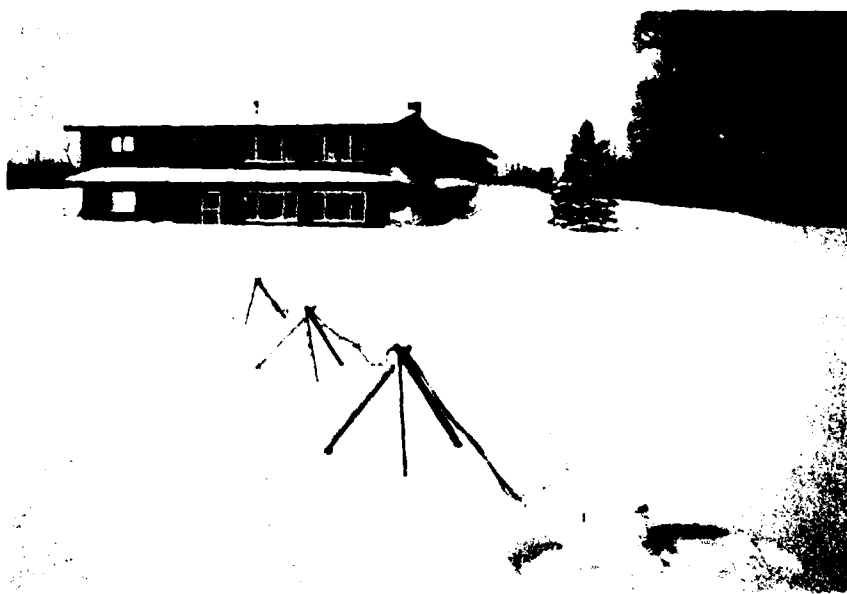
Figure 4. The Gordon site with the accelerometers on the ice under the white bucket in foreground.

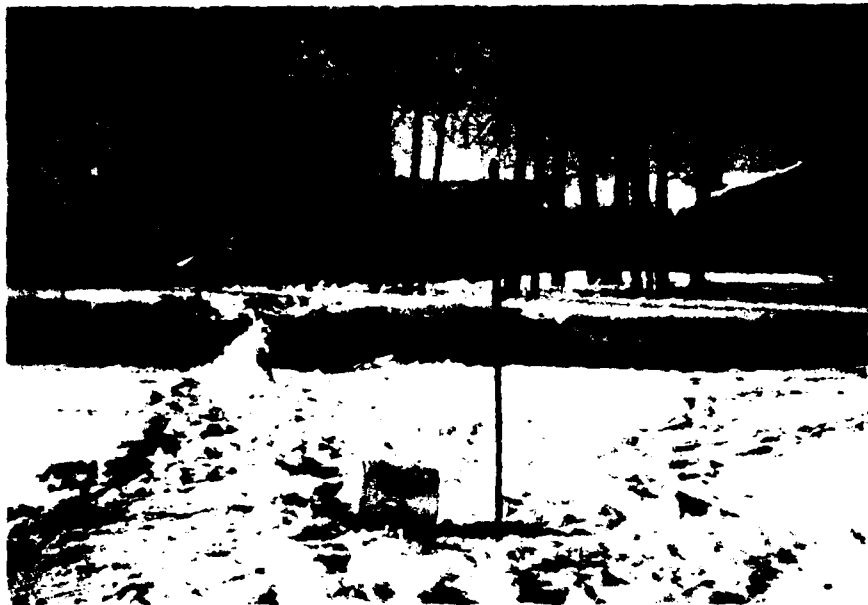
Figure 5. The Doran site with the accelerometers on the ice in the foreground

To identify the mode of vibration energy transmission, a comparison was made between the solid ice and broken ice conditions. These two conditions are shown in Figures 5 and 7 respectively. The solid ice has many cracks in it, e.g. the shoreline crack shown in Figure 56. These cracks are dry, however, and the ice sheet is continuous. In contrast, the broken ice condition is a discontinuous ice sheet (Fig. 38). Table 2 gives vibration levels for six ships under the two conditions. Again, the vertical direction geophone signal was used for the comparison, except for the *Callaway*, where the signal from the geophone parallel to the channel was used.

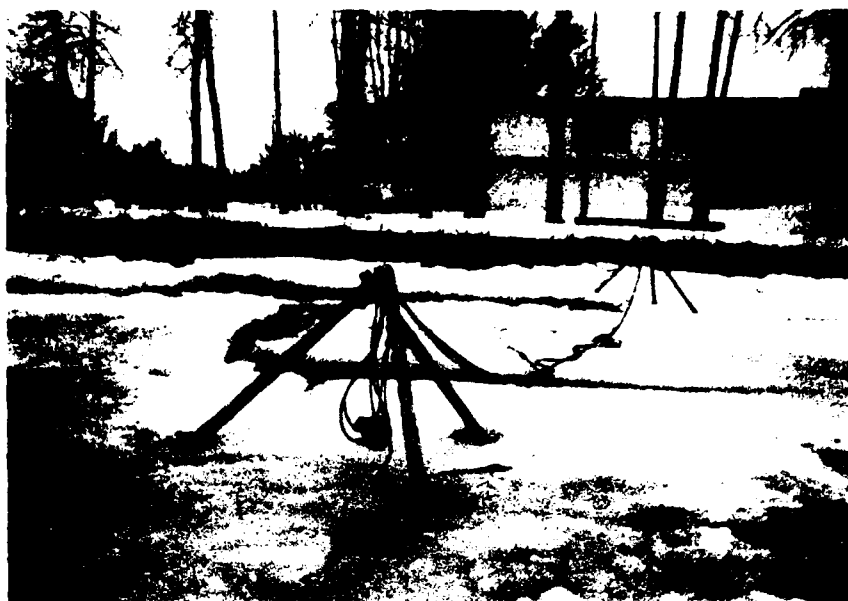
pipe. The wire rope acted as a fail-safe device which prevented the loss of the accelerometers. Figure 7 shows how the system worked during breakup.

Figure 7 Wire rope prevented loss of accelerometers during breakup

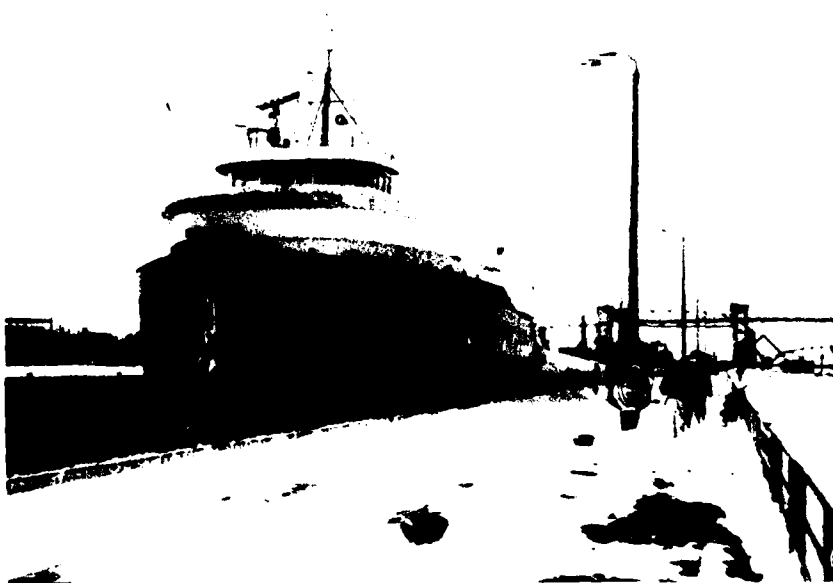
Figure 12. Cason J. Callaway locking through at Sault Ste. Marie.

In order to identify the ships as the source of vibrations we requested and received the permission of U.S. Steel to instrument one of their ore carriers. The *Cason J. Callaway*, a 233-m (767-ft) by 21.3-m (70-ft) ship with a 5.22-MW (7,000-hp) engine was chosen (Fig. 12). Three accelerometers (x, y and z directions) were placed in the bow at the waterline and three more in the stern at the waterline while the ship was in dry dock at Duluth Harbor in December 1978. Data were collected on board ship using an instrumentation recorder like those used on shore.

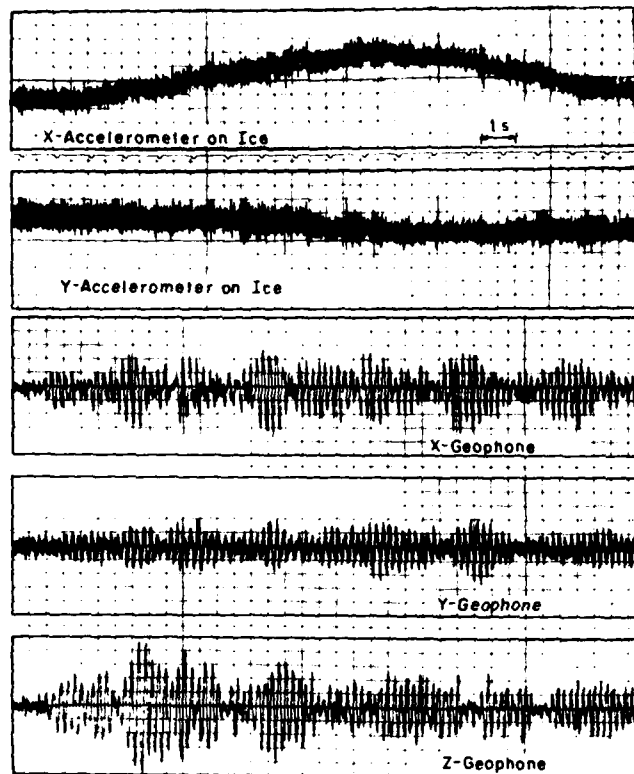
Figure 13 shows *USCGC Mackinaw* passing the Gordon site. Figure 14 is a plot of the data from the strip chart recorder for the *Mackinaw* passing the Gordon site on 20 January 1979. There were voice interrupts on channel no. 8 at the points where we observed that the bow and stern were passing the test site. The magnitudes of the transducer signals were found from Figure 14 and plotted on a standard vibration damage chart (Fig. 15). It can be seen from Figure 14 that these maximum signals were at 5 Hz, and that is how they were plotted in Figure 15. The 5-Hz frequency is the propeller noise of the *Mackinaw*, which had a four-bladed propeller operating at a shaft speed of 75 rpm. It is also evident in Figure 14 that a strong 5.5-Hz signal is present in all geophones.

Figure 14. Signals of USCGC Mackinaw passing the Gordon site at 12.8 mph on 20 January 1979.

The test results show that vibrations caused by ships can be detected. Vibration frequencies caused by propeller noise can be seen on the strip chart recorder plots: Figure 14 for the USCGC Mackinaw and Figure 19 for the Roger

The duration of strong vibration signals was determined from the strip chart records. Figures 14 and 19 show typical duration signals for the ships passing a test site where a strong signal lasted for about 10-20 s. This is comparable to signal durations found on some earthquake accelerograms (Clough and Penzien 1975). Since the time required to pass a particular site was about 60 s, the duration of vibration could potentially also be about 60 s.

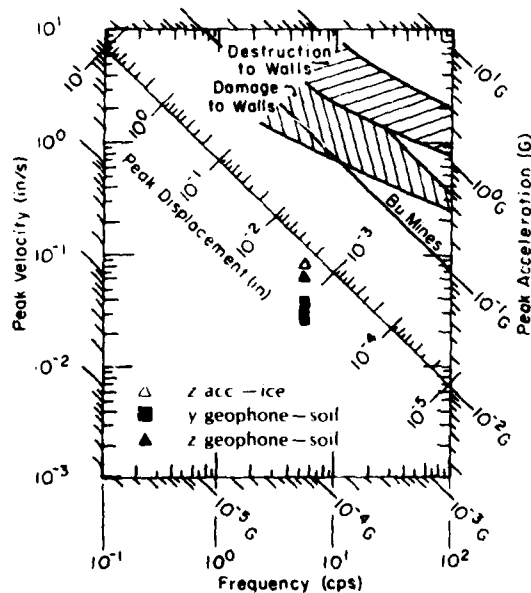
Figure 15. Magnitude of vibrations as the USCGC Mackinaw passed the Gordon site upbound on 20 January 1979 at 12.8 mph (x is perpendicular to and y is parallel to the ship channel; z is vertical).

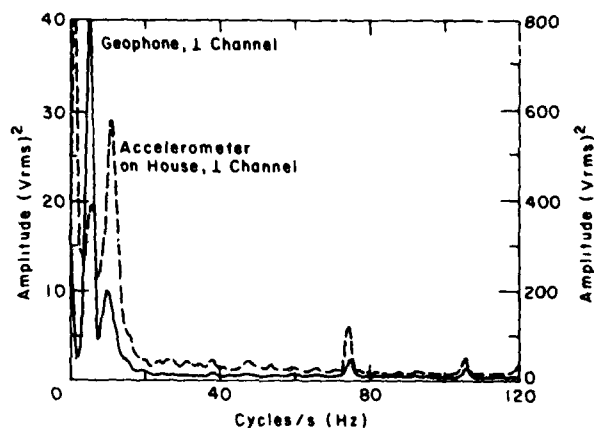
For a check on the dominant frequency an HP Digital Signal Analyzer was used. This analyzer has a two-channel input so signals from two transducers can be compared. Figure 16 shows the auto power spectra for the x-direction geophone and the x-direction accelerometer on the house. The auto spectrum is the Fourier transform of the auto correlation function in the time domain. The dominant frequency for the geophone signal is 5.5 Hz. The resolution is 0.5 Hz on a 128-Hz bandwidth for the analyzer. Therefore the 5- to 5.5-Hz frequency obtained from the strip chart recorder is confirmed by the auto spectrum. There is good correlation at 5.5 Hz for

Figure 16. Auto power spectrum plots for the geophone and accelerometer on the house (both mounted perpendicular to the channel) for the Mackinaw upbound at the Gordon site. Right scale for accelerometer, left scale for geophone.

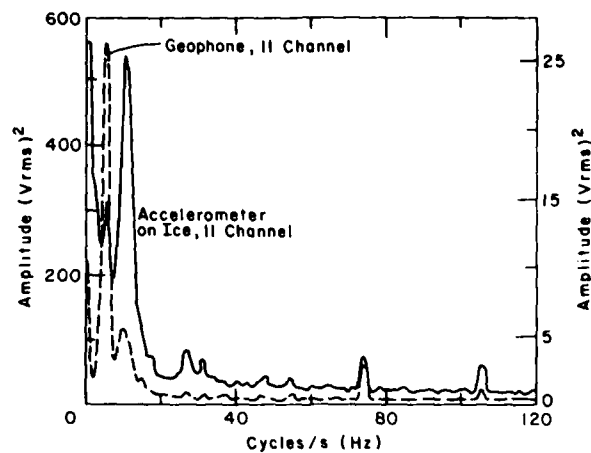
Figure 17. Auto power spectrum plots for the accelerometer on the ice and the geophone (both mounted parallel to the channel) for the Mackinaw upbound at the Gordon site. Right scale for accelerometer, left scale for geophone.

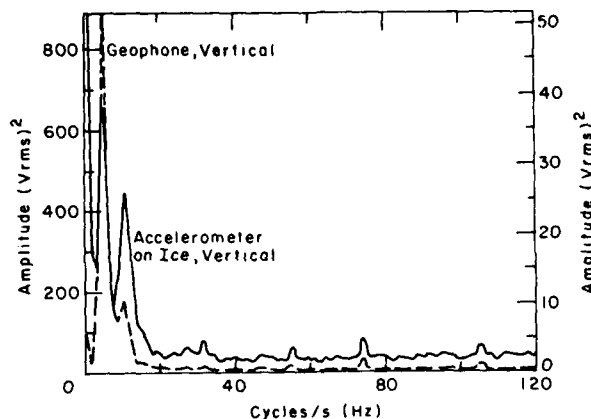
Figure 18. Auto power spectrum plots for the accelerometer on the ice and the geophone (both vertical) for the Mackinaw upbound at the Gordon site. Right scale for geophone, left scale for accelerometer.

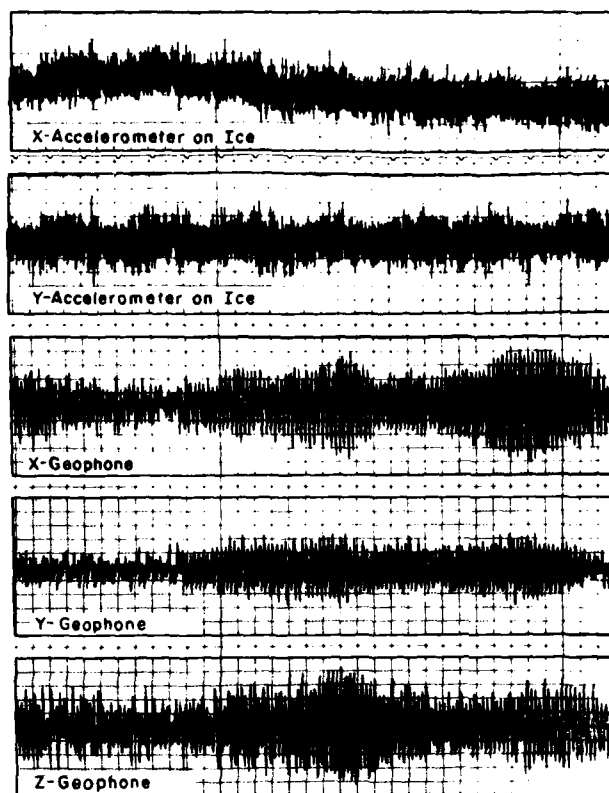
Figure 19. Signals of Roger Blough passing the Gordon site at 7.5 mph on 22 January 1979.

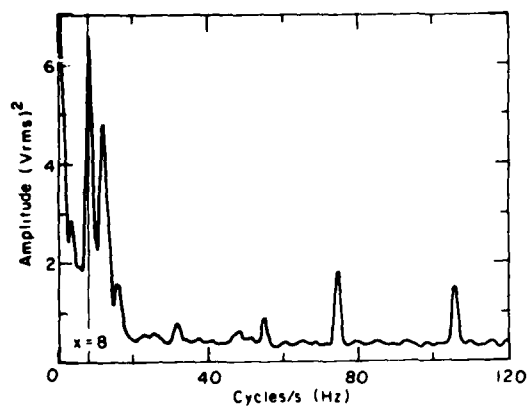
Figure 20. Auto power spectrum plot for the geophone mounted perpendicular to the channel for the Roger Blough downbound at the Gordon site.

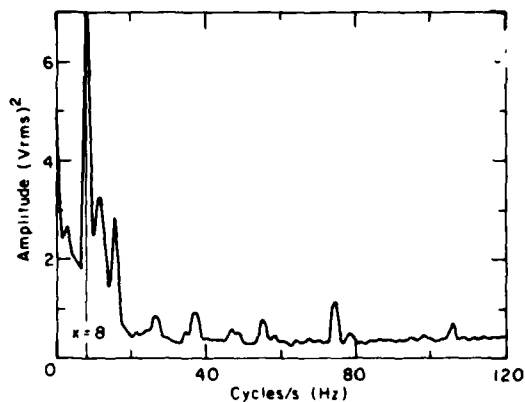
Figure 21. Auto power spectrum plot for the geophone mounted parallel to the channel for the Roger Blough downbound at the Gordon site.

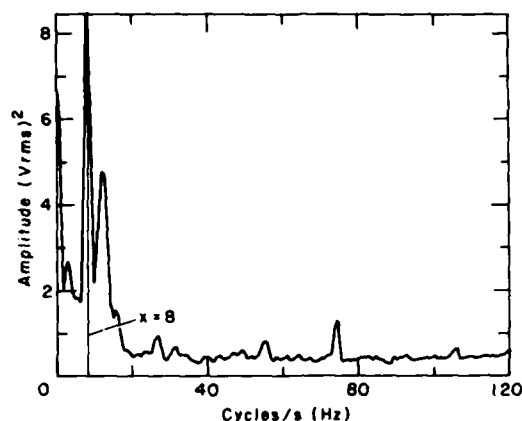
Figure 22. Auto power spectrum plot for the vertically mounted geophone for the Roger Blough downbound at the Gordon site.

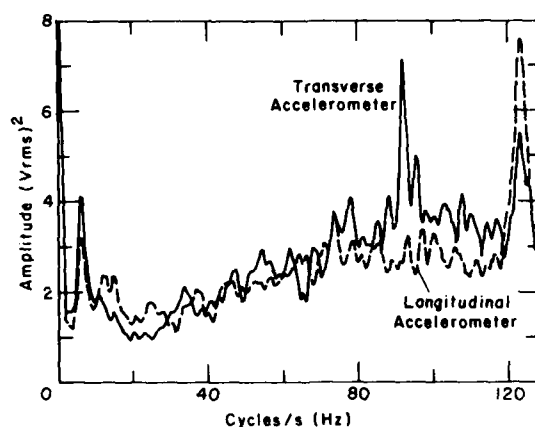
Figure 24. Auto power spectrum plots for the transverse and longitudinal direction accelerometers on the bow of the Cason J. Callaway as it passed the Gordon site downbound.

speed of 100 rpm with a four-bladed propeller. Figure 24 shows the auto power spectrum for the bow accelerometers in the transverse and longitudinal directions. The peaks at 6.5 Hz are the propeller noise since the resolution on the auto spectrum is 0.5 Hz. Figure 25 shows the auto spectrum for the accelerometers in the vertical direction, bow and stern. The peaks at 6.6 Hz are

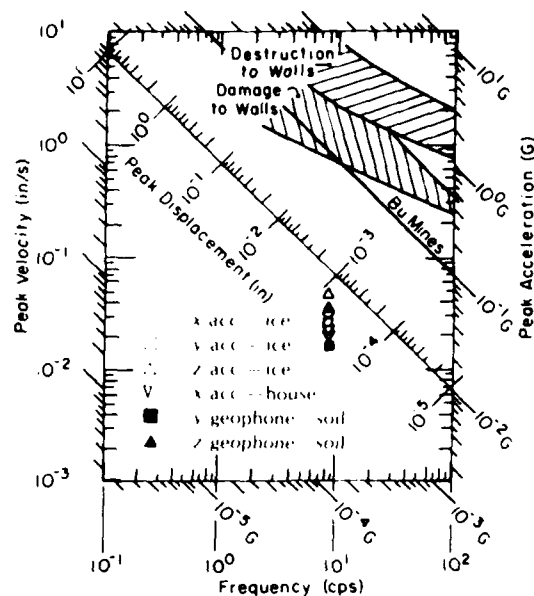
Figure 23 shows the magnitude of the Roger Blough's vibration signals on a standard vibration chart.

Figure 23. Magnitude of vibrations for the Roger Blough passing the Gordon site on 22 January 1979 at 7.5 mph (x is perpendicular to and y parallel to the ship channel; z is vertical).

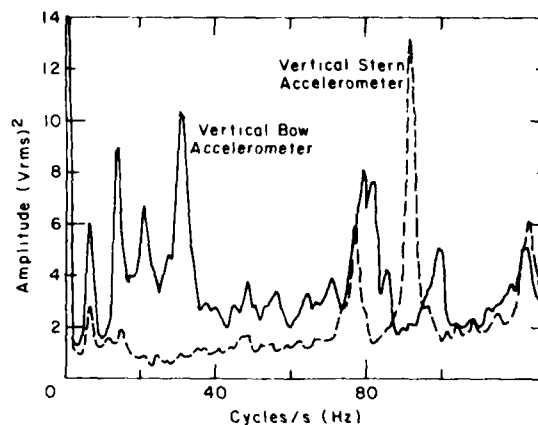
Figure 25. Auto power spectrum plots for the vertical accelerometers on the bow and stern of the Cason J. Callaway as it passed the Gordon site.

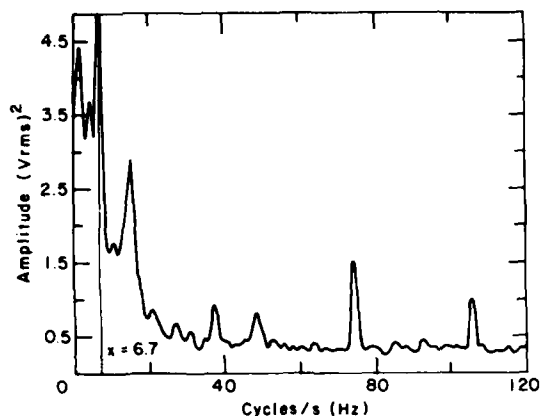
Figure 26. Auto power spectrum plot for the geophone mounted perpendicular to the channel as the Cason J. Callaway passed the Gordon site downbound.

the propeller noise, which is stronger for the stern than the bow, as expected. Positive identification of the propeller noise on shore is furnished by the geophone auto spectra in Figures 26 and 27. The 6.7-Hz signal was picked up by geophones as the Cason J. Callaway passed the Gordon site. This same frequency was found for the maximum vibration signals as the Callaway passed the Doran site. It should be noted that

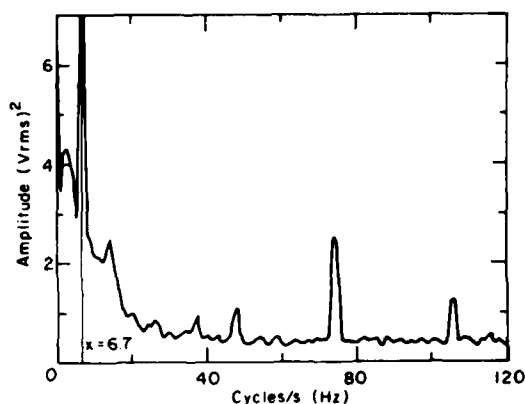
Figure 27. Auto power spectrum plot for the geophone mounted parallel to the channel as the Cason J. Callaway passed the Gordon site downbound.

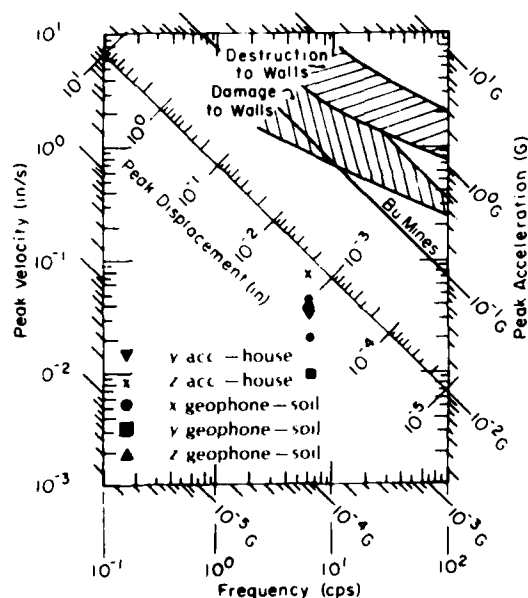
Figure 28. Magnitude of vibrations for the Cason J. Callaway passing the Doran site downbound on 10 February 1979 (x is perpendicular to and y is parallel to the ship channel; z is vertical).

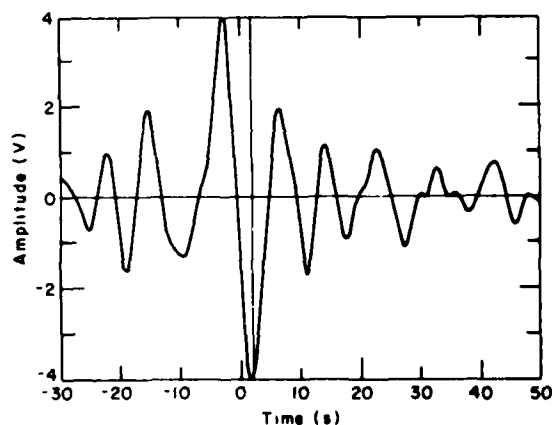
Figure 29. Time record for the accelerometer mounted in the transverse direction on the bow of the Cason J. Callaway.

On 11 February 1979 the Callaway encountered some strong ice in Lake Michigan about 10 miles north of Gary, Indiana. Figure 29 shows the time record for the bow accelerometer in the

transverse direction. The magnitude indicates a 3.17-g level; however, the accelerometer used was linear up to 2 g so there is little confidence above that level. Figure 30 shows the dominant frequency for the transverse bow accelerometer to be 97.5 Hz. The natural frequency of the accelerometer is 104 Hz, but the internal damping ratio is 0.6 so resonance effects should be negligible. The time record for the bow accelerometer in the longitudinal direction is shown in Figure 31. A 1.42-g vibration level is indicated. Figure 32 gives the dominant frequency at 91.5 Hz for this direction. The time record for the bow accelerometer in the vertical direction is shown in Figure 33. A vibration level of 2.4 g is indicated but this exceeds the 2-g range of the

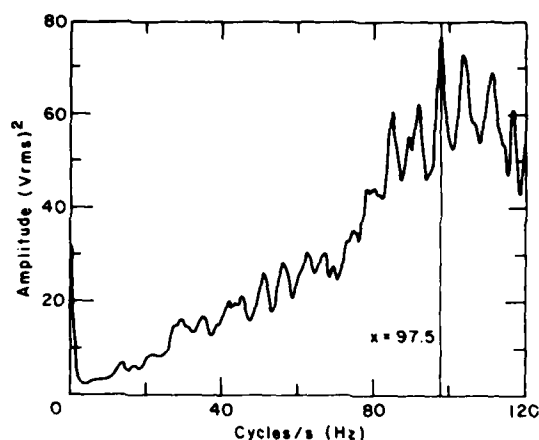
Figure 30. Auto power spectrum for the accelerometer mounted in the transverse direction on the bow of the Cason J. Callaway.

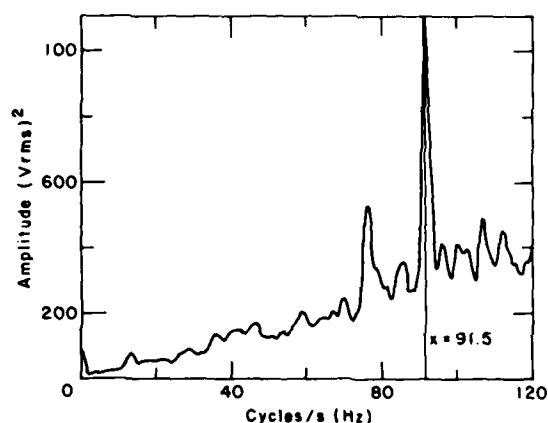
Figure 32. Auto power spectrum for the accelerometer mounted in the longitudinal direction on the bow of the Cason J. Callaway.

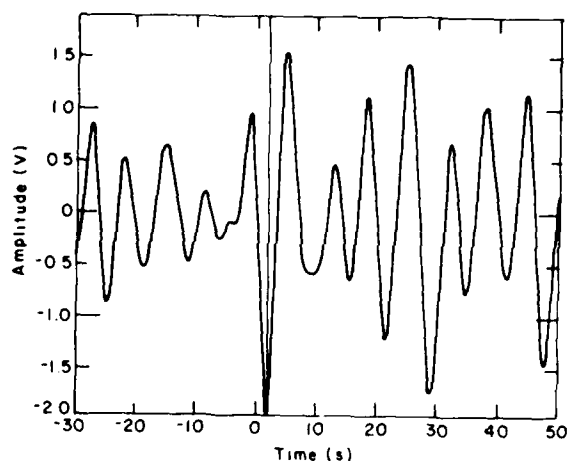
Figure 31. Time record for the accelerometer mounted in the longitudinal direction on the bow of the Cason J. Callaway.

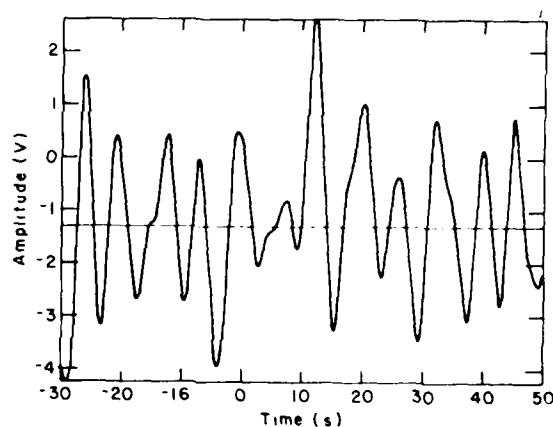
Figure 33. Time record for the accelerometer mounted in the vertical direction on the bow of the Cason J. Callaway.

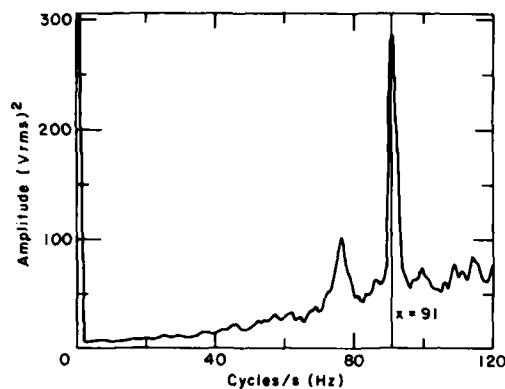
Figure 34. Auto power spectrum for the accelerometer mounted in the vertical direction on the bow of the Cason J. Callaway.

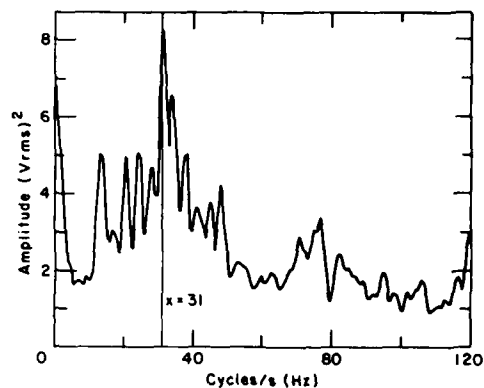
The three accelerometers mounted in the stern did not indicate the high frequencies or the high magnitudes that those mounted in the bow did. Figure 35 is the auto spectrum for the stern accelerometer in the transverse direction. The vibration level is about one order of magnitude lower than that found for the bow transverse accelerometer shown in Figure 30. Figure 36 is the auto spectrum for the stern longitudinal vibration. The auto spectrum for the stern vertical accelerometer is shown in Figure 37. Magnitude comparisons for vertical bow and stern accelerometers show that the bow level is about 19 times the stern level.

Figure 35. Auto power spectrum for the accelerometer mounted in the transverse direction on the stern of the Cason J. Callaway.

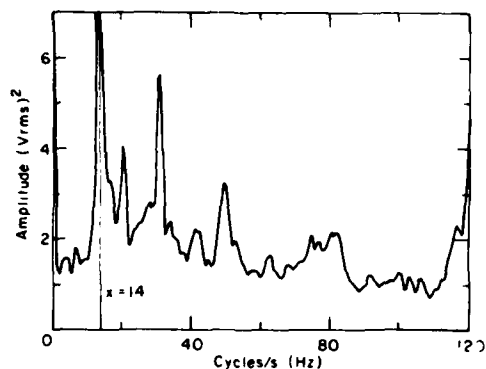
Figure 36. Auto power spectrum for the accelerometer mounted in the longitudinal direction on the stern of the Cason J. Callaway.

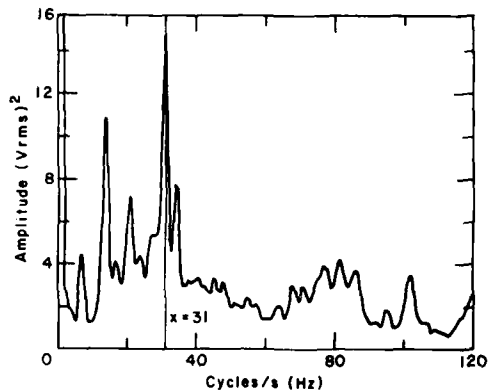
Figure 37. Auto power spectrum for the accelerometer mounted in the vertical direction on the stern of the Cason J. Callaway.

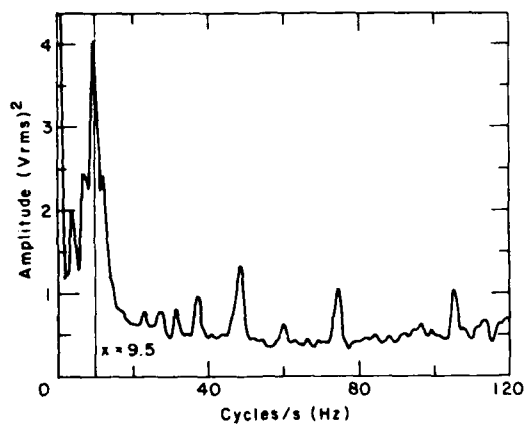
Figure 39. Auto power spectrum for the accelerometer mounted perpendicular to the channel on the ice as the Imperial St. Clair passed the Doran site.

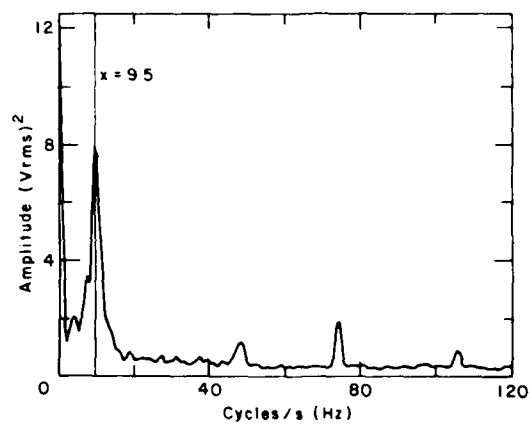
Figure 40. Auto power spectrum for the accelerometer mounted perpendicular to the channel on the house as the Imperial St. Clair passed the Doran site.

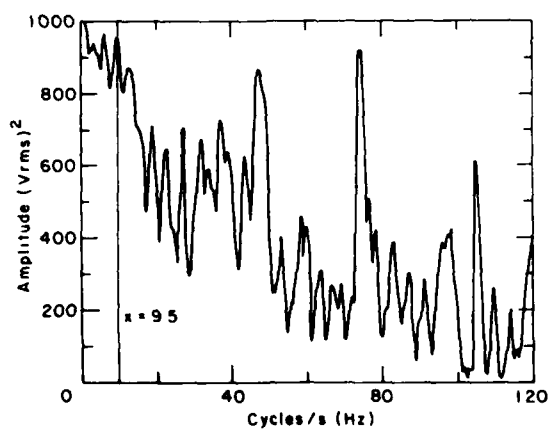
Figure 41. Coherence function for the accelerometers mounted perpendicular to the channel on the ice and house as the Imperial St. Clair passed the Doran site.

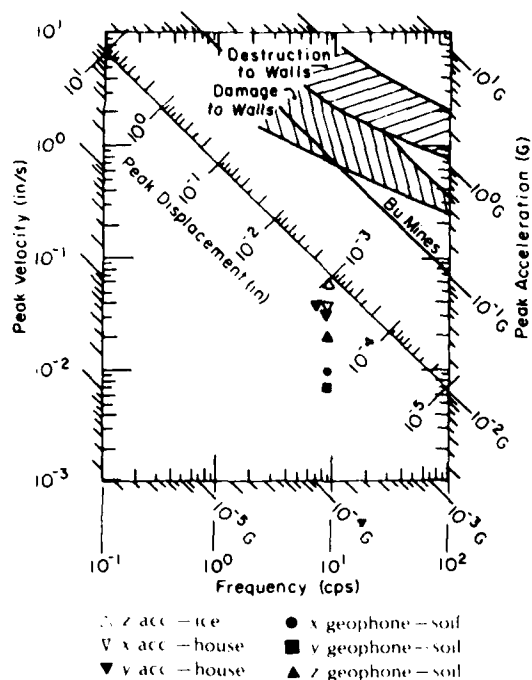
Figure 42. Magnitude of vibrations as the Imperial St. Clair passed the Doran site downbound on 8 March 1979 at 9.9 mph (x is perpendicular to and y is parallel to the ship channel; z is vertical).

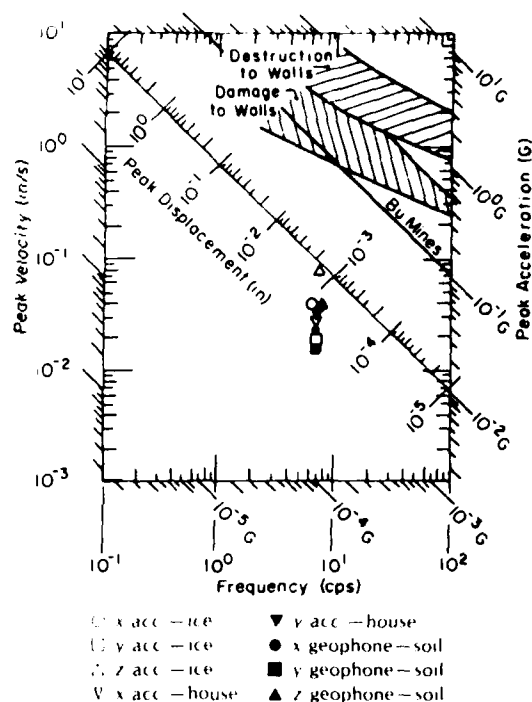
Figure 43. Magnitude of vibrations as the George Stinson passed the Gordon site downbound on 23 January 1979 at 7.4 mph (x is perpendicular to and y is parallel to the ship channel; z is vertical).

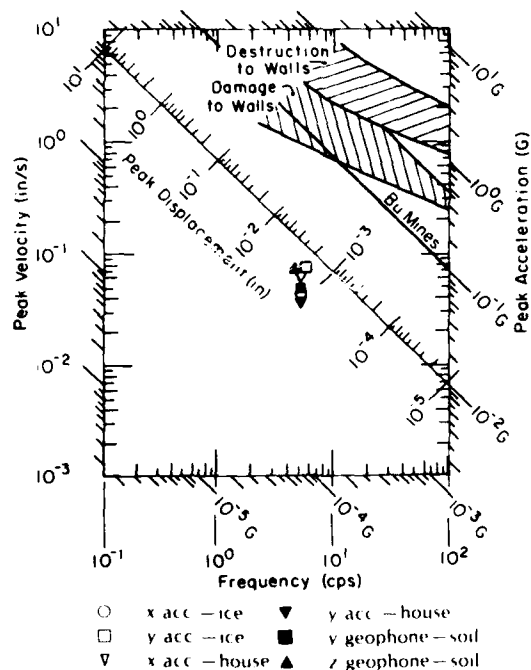
Figure 44. Magnitude of vibrations as the USCGC Mackinaw passed the Gordon site upbound on 19 February 1979 at 6.2 mph (x is perpendicular to and y is parallel to the ship channel; z is vertical).

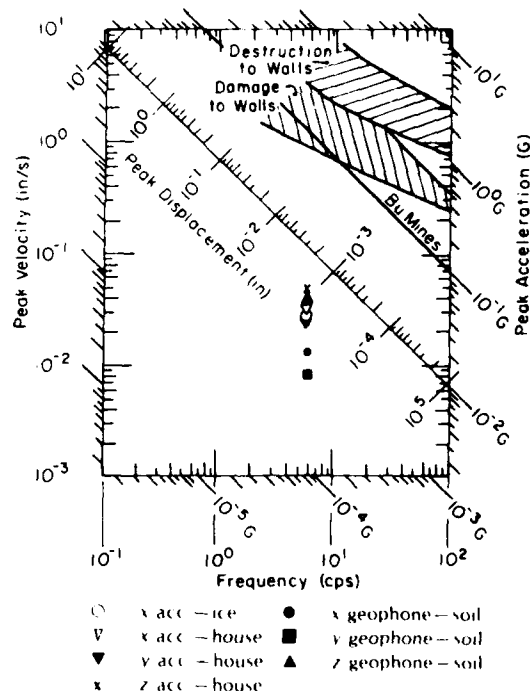
Figure 45. Magnitude of vibrations as the USCGC Mackinaw passed the Doran site upbound on 16 February 1979 at 8.5 mph (x is perpendicular to and y is parallel to the ship channel; z is vertical).

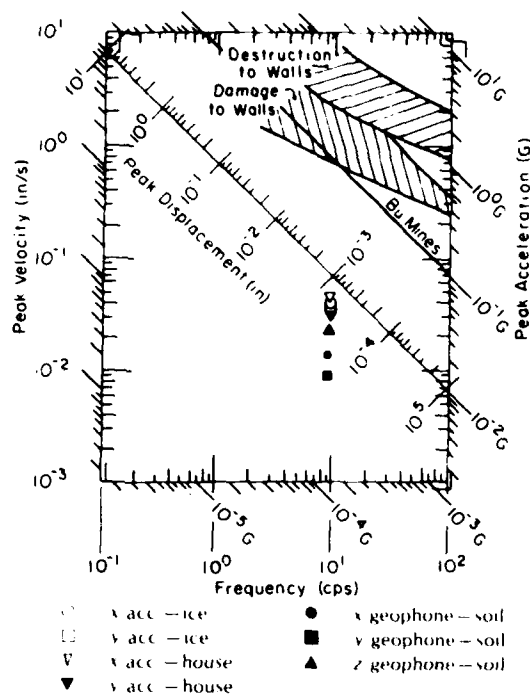
Figure 46. Magnitude of vibrations as the Roger Blough passed the Doran site upbound on 18 March 1979 at 7.4 mph (x is perpendicular to and y is parallel to the ship channel; z is vertical).

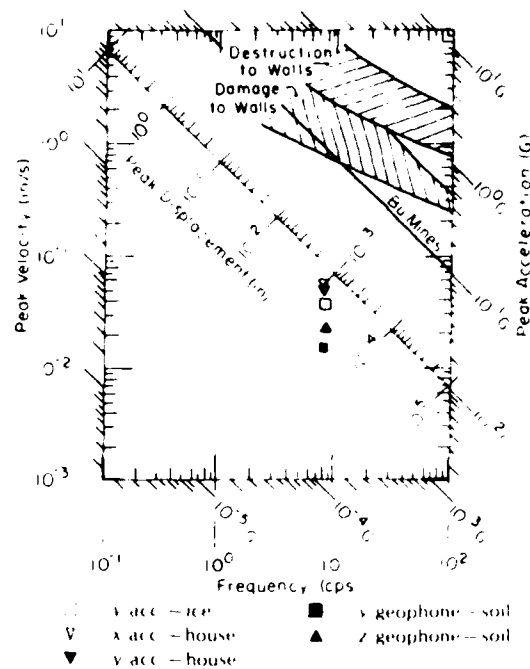
Figure 47. Magnitude of vibrations as the Roger Blough passed the Doran site upbound on 24 February 1979 at 6.8 mph (x is perpendicular to and y is parallel to the ship channel; z is vertical).

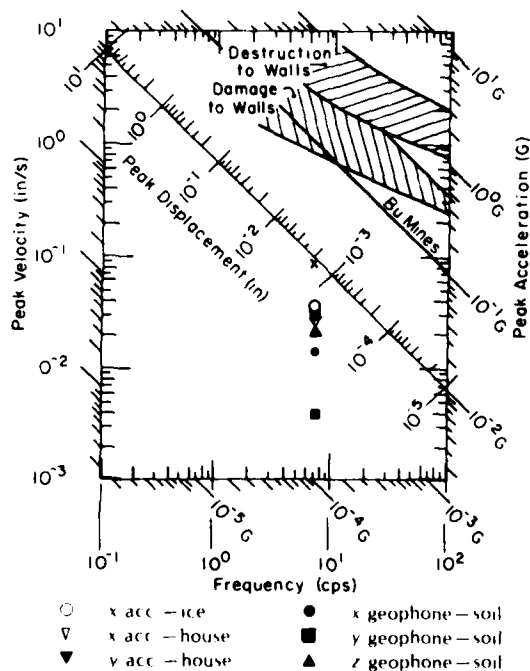
Figure 48. Magnitude of vibrations as the Philip Clarke passed the Doran site downbound on 10 February 1979 (x is perpendicular to and y is parallel to the ship channel; z is vertical).

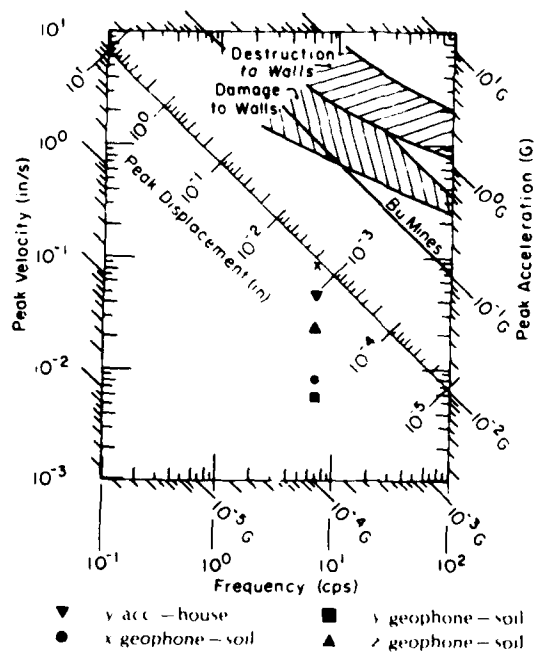
Figure 49. Magnitude of vibrations as the Philip Clarke passed the Doran site downbound on 21 March 1979 at 11.5 mph (x is perpendicular to and y is parallel to the ship channel; z is vertical).

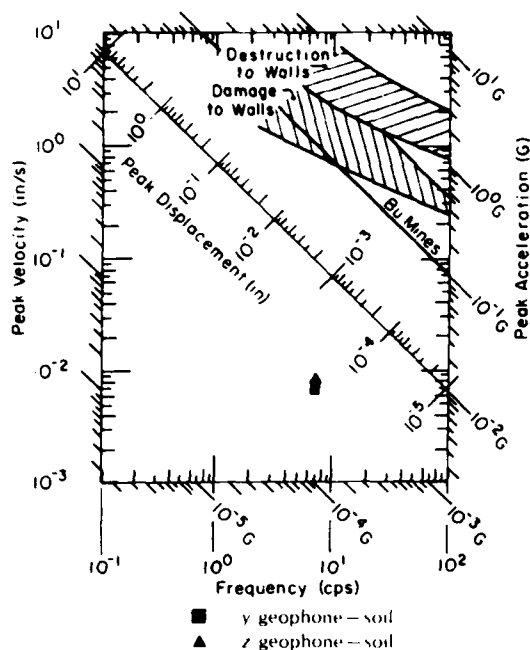
Figure 50. Magnitude of vibrations as the Philip Clarke passed the Gordon site downbound on 3 April 1979 at 9.3 mph in open water.

for the open water condition is barely above the threshold of perception.

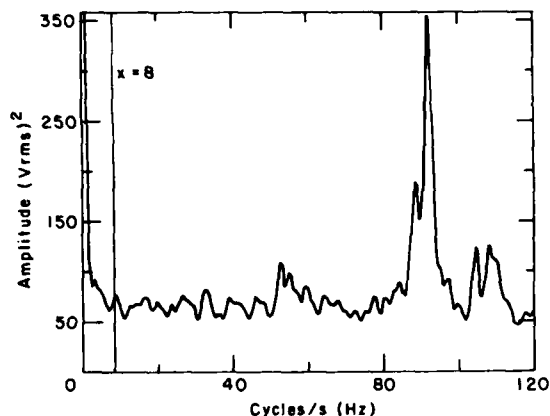
Figure 52. Auto power spectrum for the hydrophone as the Roger Blough passed the Doran site.

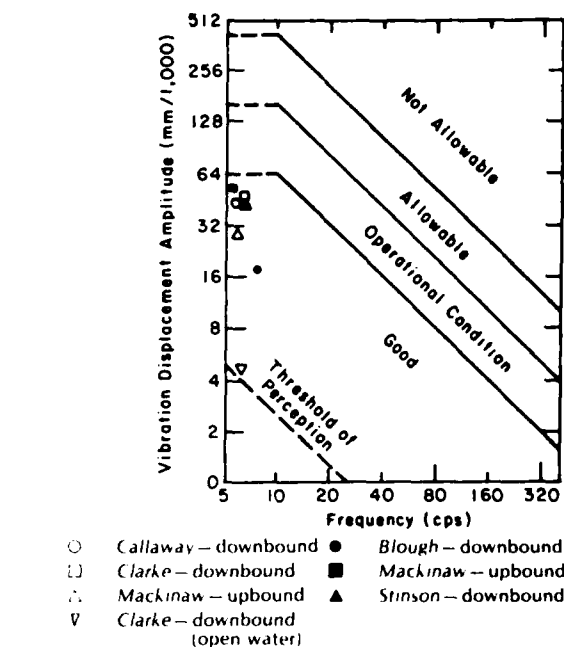
To answer the question of whether the vibration levels are great enough to be perceived, the maximum vibration displacements for six ship passages were plotted on a standard chart given in Harris and Crede (1975). This chart is for rotating machinery conditions and the allowable limits might tend to be higher than those acceptable for a residence. Figure 51 shows that the vibrations can be perceived. The one data point

Figure 51. Levels of vibration for seven ships passing the test sites (white symbols represent the Doran site, dark symbols the Gordon site).

were examined in detail. Maximum vibration signals were found for each transducer and the results were plotted on a standard vibration chart taken from Harris and Crede (1975). These vibration signals were plotted at the dominant frequency as seen on the strip chart record and verified with an auto power spectrum analysis.

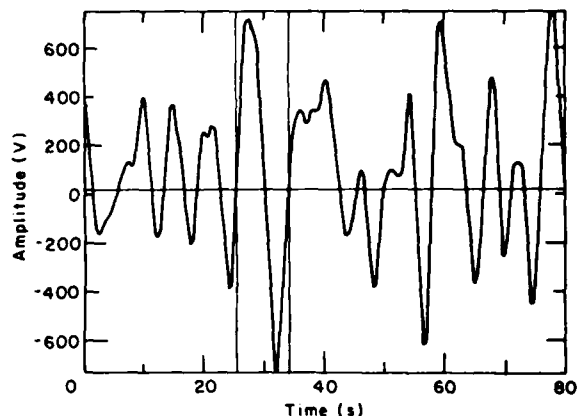
Figure 53. Time record for the hydrophone as the Roger Blough passed the Gordon site.

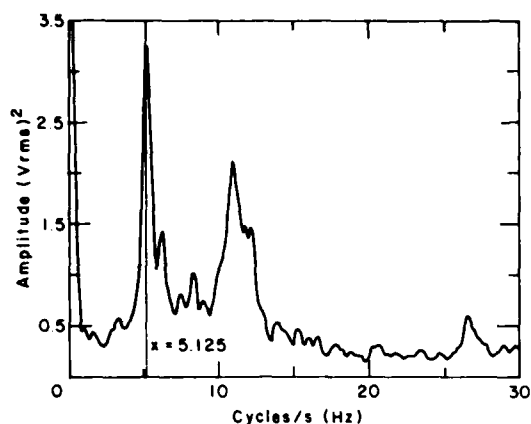
Figure 54. Auto power spectrum for the accelerometer mounted on the ice in the vertical direction as the USCGC Mackinaw passed the Gordon site upbound.

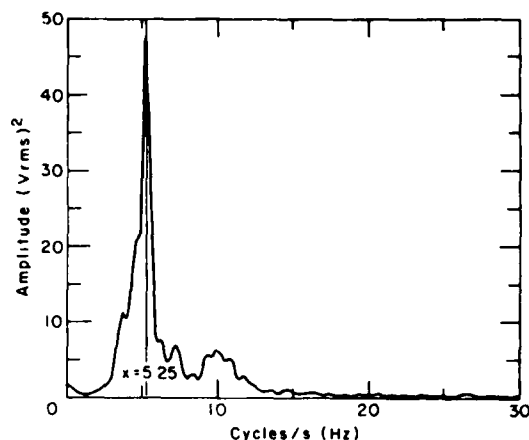
Figure 55. Auto power spectrum for the geophone mounted in the vertical direction as the USCGC Mackinaw passed the Gordon site upbound.

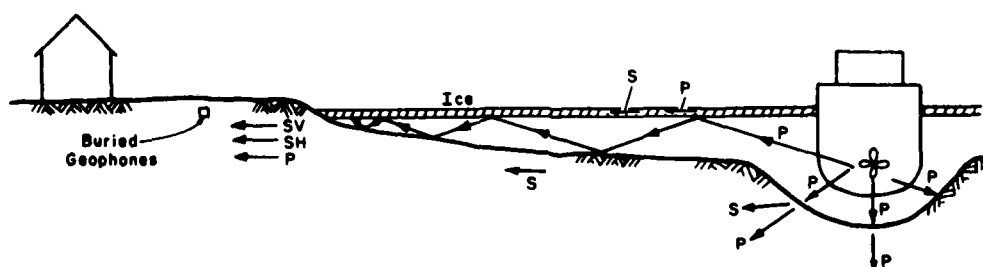
broken ice sheet. Also, the discussion will focus on the fact that the vertical motion was the largest, as measured by the buried geophones. Figure 57 shows the three modes and their paths.

Figure 57. Seismic wave paths.

There will be energy transmission through the soil with or without an ice cover. The incident *P* wave will cause refracted *P* and *S* waves and Rayleigh waves in the bed. These will propagate to shore. Reflected *P* waves from underlying bedrock and refracted *P* waves from denser layers, which could cause large vertical component vibrations, are not considered because they will be unaffected by the presence of an ice cover. As the *S* waves and Rayleigh waves propagate towards shore their energy could be amplified by the interaction with incident *P* waves from the

Incident *P* waves from the water can cause refracted *P* and *S* waves in an ice cover. These *S* waves can propagate towards shore and cause the large vertical vibration signals that we obtained. However, the results in Table 2 indicate that there is not much difference in vibration levels between solid ice and broken ice. The broken-up ice pieces would all have to be in contact for the *S* waves to be transmitted to shore. The *P* waves could be transmitted to shore whether the ice pieces were in contact or not and could possibly generate *S* waves where the shore-fast ice contacts the shore.

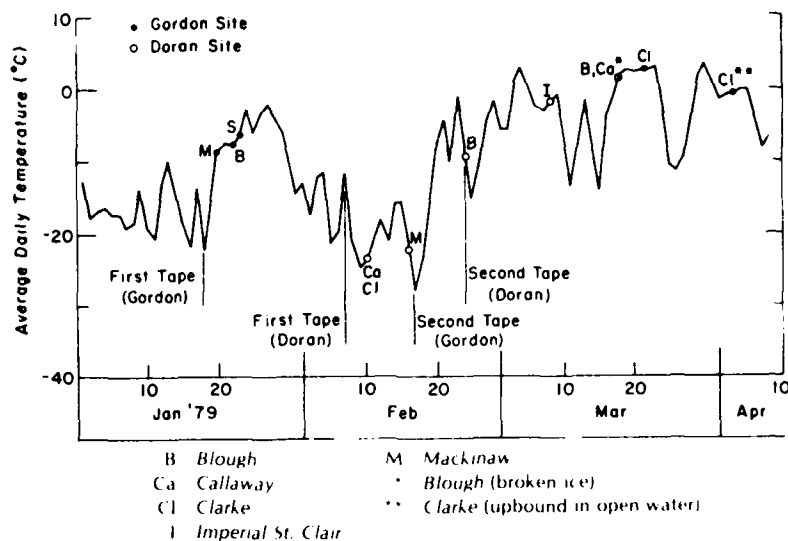
We investigated the effect that weather conditions might have on the level of vibrations. Figure 58 shows the average daily temperature for Sault Ste. Marie, Michigan from 1 January to 8 April 1979. The data for this figure were obtained from NOAA (1979). The first data were collected at the Gordon site on 18 January and at the Doran site on 7 February. We postulated

Figure 58. Average daily temperature for 1 January through 10 April 1979, Sault Ste. Marie, Michigan.

that cold, high modulus, low damping ice could transmit high vibration levels. In Figure 58, the highest vibration levels found are associated with the first six ships in chronological order. The passage of ships did not always concur with low temperatures. The first three ships, Mackinaw, Blough, and Stinson, were recorded after a cold period, 16-18 January, and at the beginning of a warming cycle. The next three ships, Callaway, Clarke and Mackinaw, were recorded at the Doran site during a definite cold period. After 20 February the weather remained comparatively warm and the vibration levels tended to be lower. However, many other variables are involved in the vibration levels produced, such as ship speed, energy expended, ship size and soil conditions. It appears that there is no definite conclusion to be reached on the weather effect from the data of 1979. The uncoupling effect of the unfrozen soil tended to dampen out any weather effect.
